ROYAL AERONAUTICAL SOCIETY
FLIGHT OPERATIONS GROUP
SPECIALIST DOCUMENT

AEROPLANE UPSET RECOVERY TRAINING, HISTORY, CORE CONCEPTS & MITIGATION

INTRODUCTION TO AEROPLANE UPSET RECOVERY TRAINING HISTORY, CORE CONCEPTS & MITIGATION

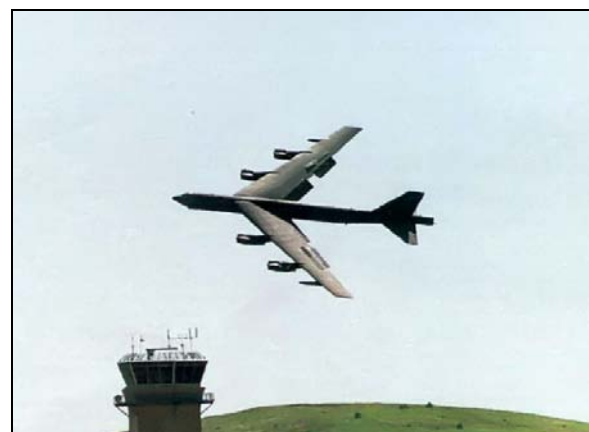
The B-52 on its final steeply banked 360° turn, round the control tower, with flaps & spoilers deployed.
From Wikipedia, the free website encyclopaedia

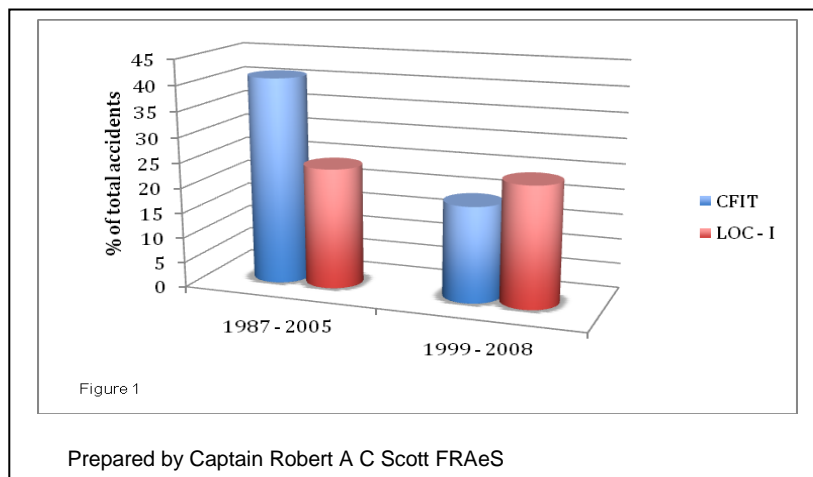
The chart at Figure 1 illustrates the relationship between loss of control in flight (LOC-I) accidents and those caused by Controlled Flight into Terrain (CFIT). It has been simplified in order to provide only a comparison between the two major causal factors under discussion. The data has been drawn from two studies, one by The Boeing Aircraft Company and the other by ICAO. The left group (1987- 2005) shows CFIT / LOC - I data prior to the development and deployment of sophisticated TAWS/EGPWS equipment (Terrain Alerting and Warning System/Enhanced Ground Proximity Warning System). The right group displays the same data for the period 1999 to 2008, and shows that Loss of Control In-flight replaced CFIT as the main causal factor for fatal accident to the Worldwide Commercial Jet Fleet.

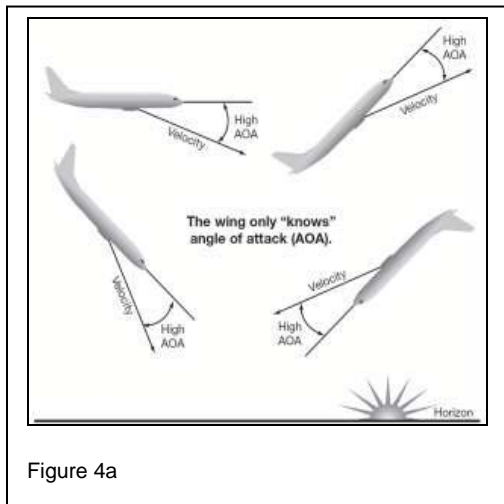
AOA is also denoted by “alpha” (α), and is the angle of the average chord line of the wing to the relative airflow, (See figure 4a)

The lift generated by a wing depends on the airspeed and the density of the air, together with the wing’s shape, area, and AOA; these last three factors comprise the “coefficient of lift”.

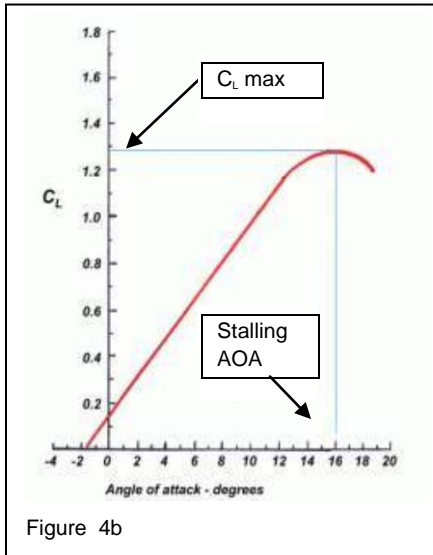
The coefficient of lift changes with the AOA but is independent of the airspeed. As the wing’s AOA increases, the coefficient of lift increases to a maximum point and then rapidly decreases (Figure 4b), so further increase in AOA beyond this point results in a decrease of lift and an increase of drag. The AOA at which the maximum lift is produced is known as the **stalling or critical AOA**.

If the AOA is increased beyond critical AOA (stall angle), the smooth flow of air over the wing will break down and the wing will stall resulting in a decrease of lift. This is true regardless of aeroplane speed or attitude. Therefore, to

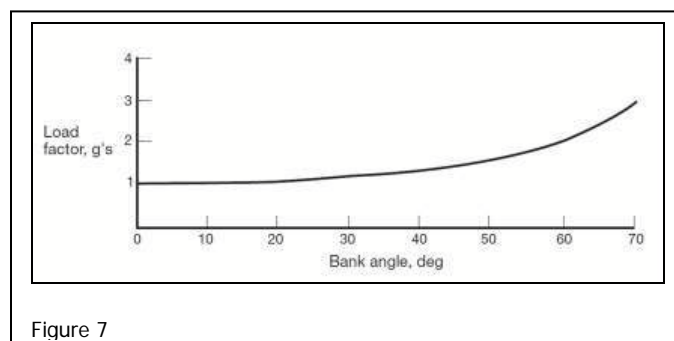
Figure 7

All of this is well known, but deserves review in the context of recovery from an upset. To arrest a descent in an over-banked nose low attitude, increasing g-load by applying back pressure on the control column will only cause a tighter turn. Depending on the bank angle, such action may *not* contribute significantly to generating a lift vector that points away from the ground. Indeed, maintaining level flight at bank angles beyond 66° requires a larger load factor than the 2.5g for which transport aeroplanes are generally certificated (See Figure 7).

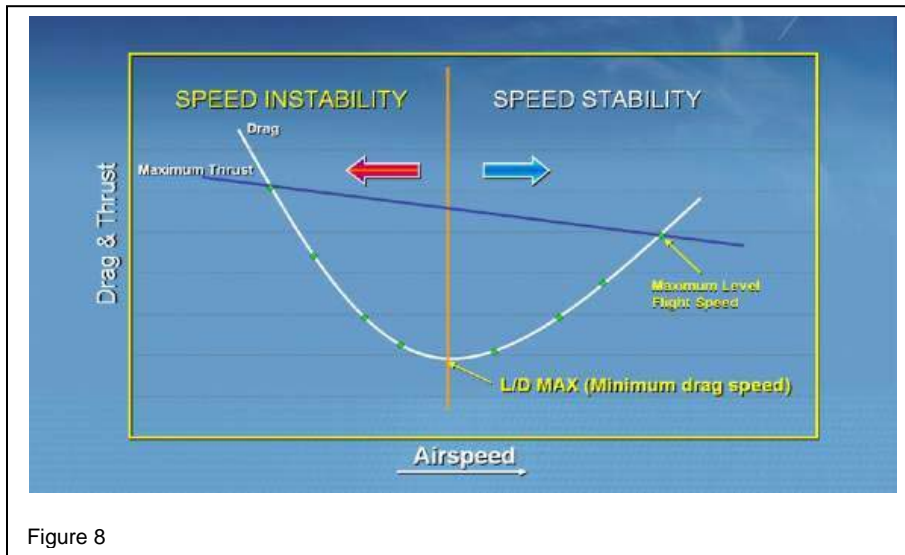
Figure 8

Slow flight (slower than L/D max) is inherently unstable with respect to speed and thrust settings. When operating at a constant airspeed, with constant thrust setting, any disturbance causing a decrease in airspeed will result in a further decrease in airspeed unless thrust is increased. The lower speed subjects the aeroplane to increased drag. This increase in drag causes a further decrease in airspeed, which may ultimately result in a stalled flight condition. (See Figure 8)
